A+ Residential Inspection Services

RE: 1313 Some St
Somewhere, TN 38505

SUMMARY OF AREAS REQUIRING FURTHER EVALUATION

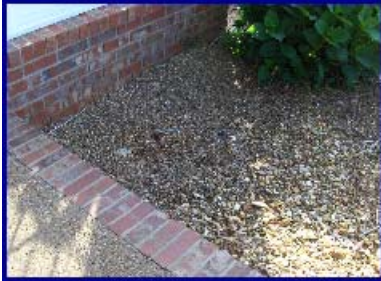
2.4 Drainage Mode

1. Grading and drainage is negative or neutral adjacent to the house and should be corrected to prevent potential water intrusion.

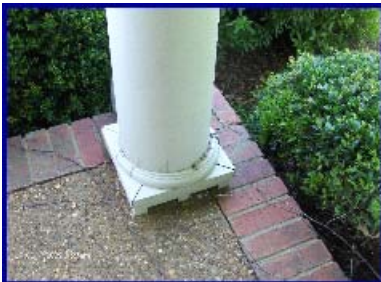
2.6 House Wall Finish Observations

2. The house wall finish is in acceptable condition.

Portions of the columns need typical maintenance.

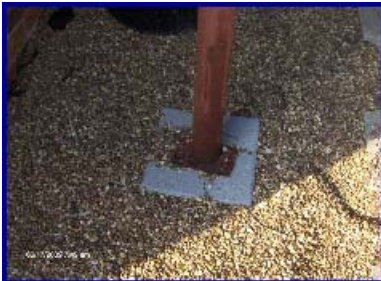
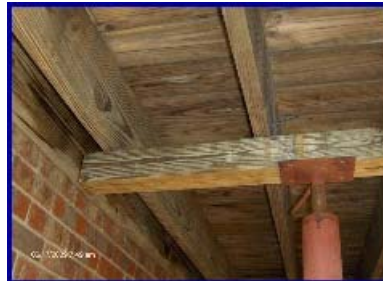
2.12 Balconies Guardrails etc

3. The support underneath the hot tub is sitting on a stepping stone that is cracked.

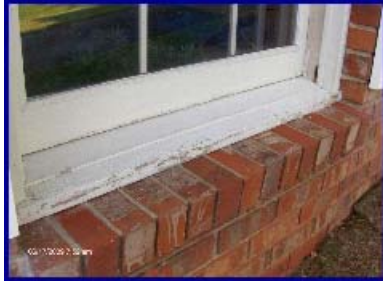
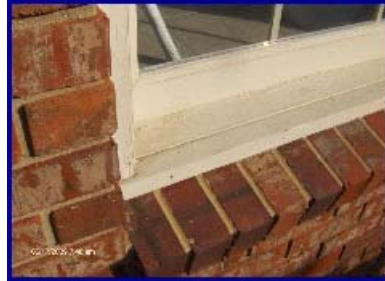
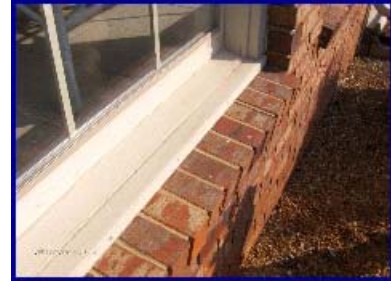
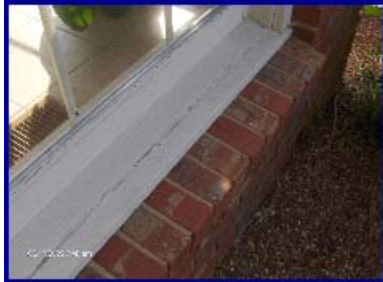
2.15 Windows

4. The window-trim needs maintenance-type service, and particularly that on the south facing side that is exposed to direct sunlight.

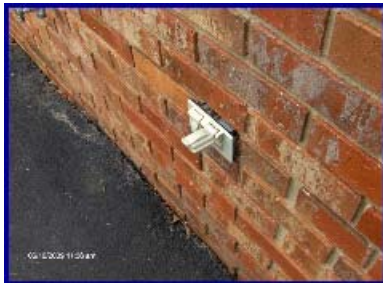
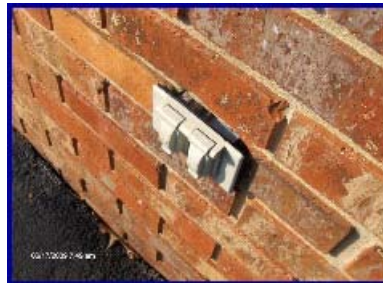
2.17 Outlets

5. An outlet in the rear of the house needs to be secured to the house to prevent it from moving.

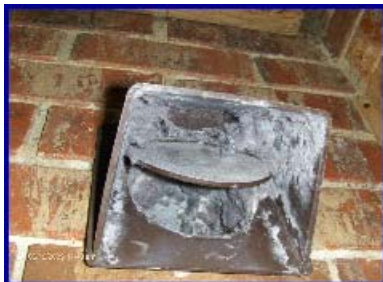
2.19 Dryer Vent

6. Excessive lint should be removed from vent to improve efficiency and to prevent fires.

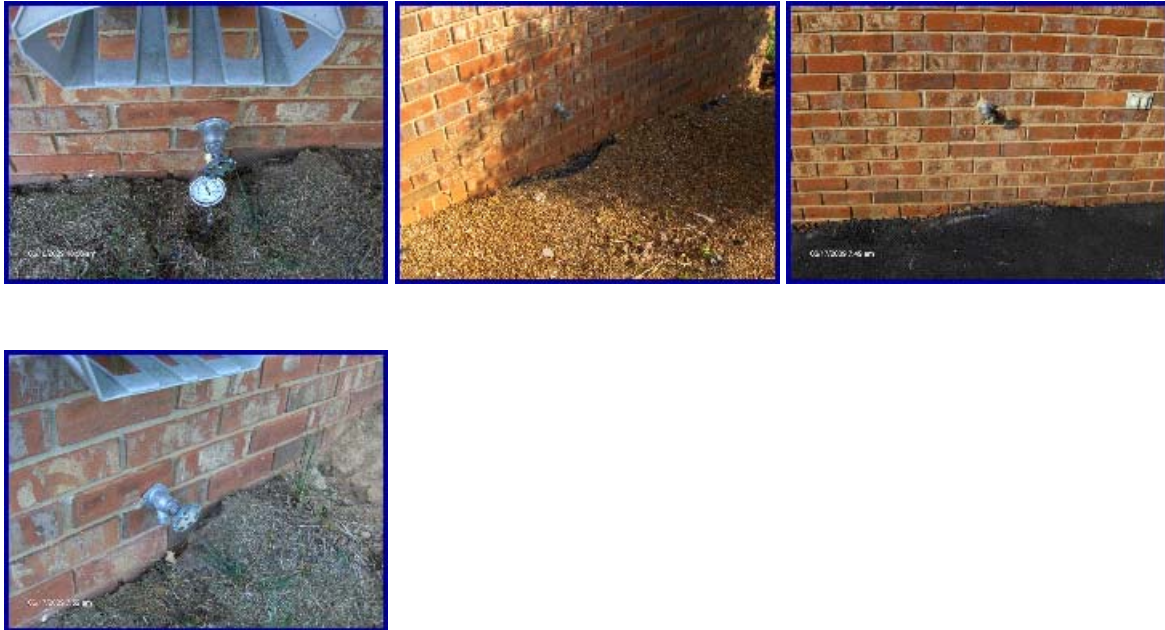
2.20 Exterior Water Faucet

7. All three water faucets are leaking at the stem and should be repaired or replaced.

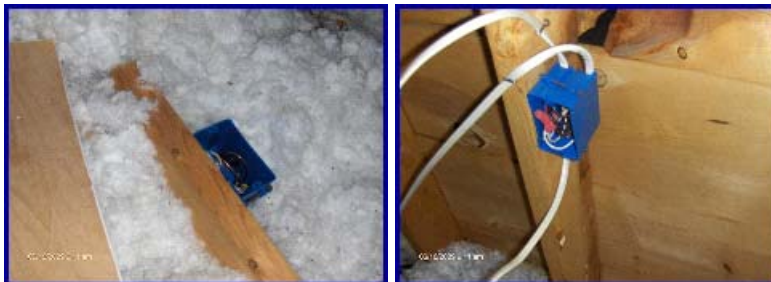
Primary Attic
4.5 Electrical

8. There are open electrical junction boxes, which should be sealed to contain any arcing or sparking that might occur.

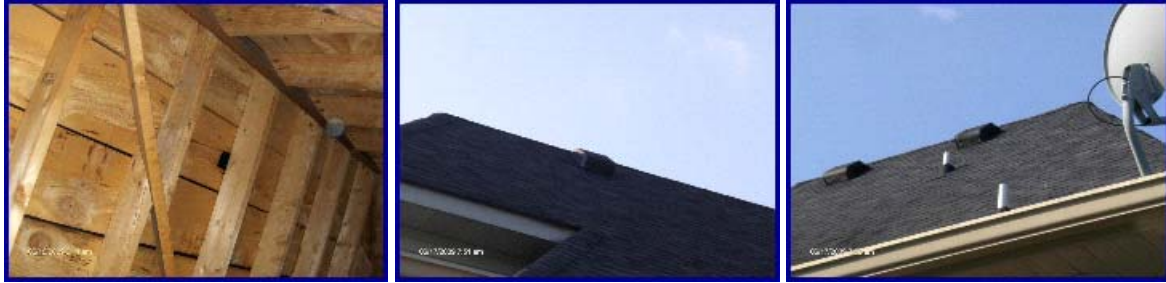
4.6 Heat Vents

9. The heat vents appear to have been covered by the roof sheathing.

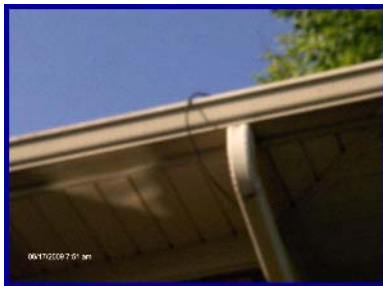
5.1 General Comments

10. The satellite cable runs across the roof, which is never recommended.

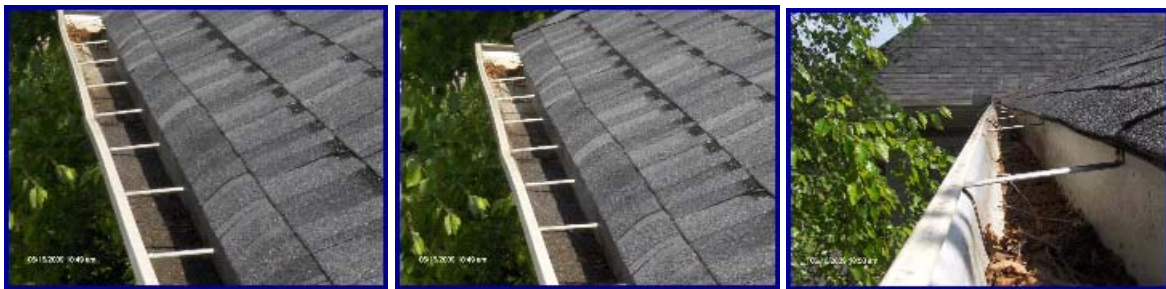
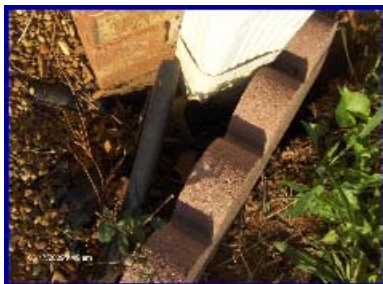
5.6 Gutters & Drainage

11. The roof needs to be cleaned and any foliage trimmed away to facilitate drainage.

Some gutter extensions need maintenance.

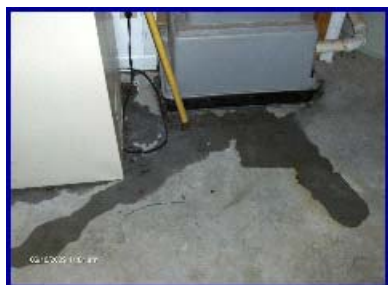
7.15 Drain Waste & Vent Pipes

12. Based on industry recommended water tests, the drainpipes are functional at this time. However, only a video-scan of the main drainpipe could confirm its actual condition.

The lift pump for the bathroom in the basement is not functioning properly. There was evidence of leaking water from the vicinity and should be further evaluated by a qualified professional.

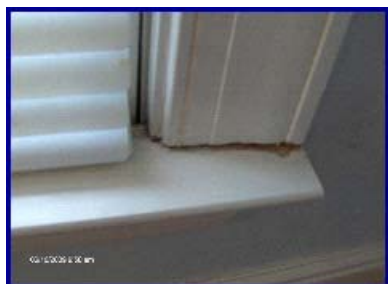
9.13 Window or Windows

13. The window or windows are double pane.
The window sill is loose and will need maintenance.

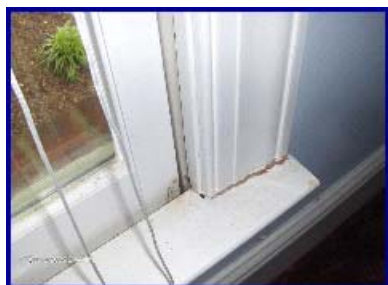
9.23 Window or Windows

14. The window or windows are double pane.
The window sill is loose and will need maintenance.

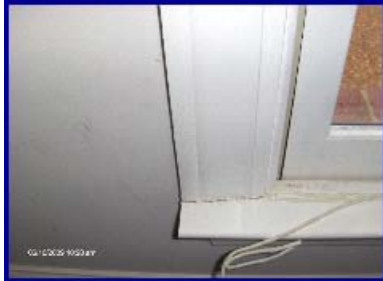
9.41 Window or Windows

15. The window or windows are double pane.
The window sill is loose and will need maintenance.

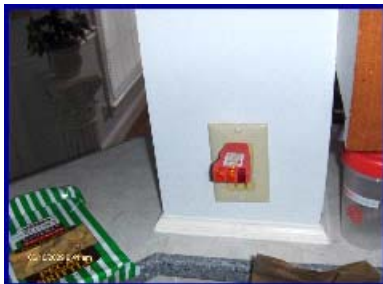
10.7 Outlets

16. GFCI Outlets, The ground-fault outlets are not operating correctly. The outlets should have the ground fault plugs replaced. Operational ground fault plugs mandated by current standards and are an important safety feature.

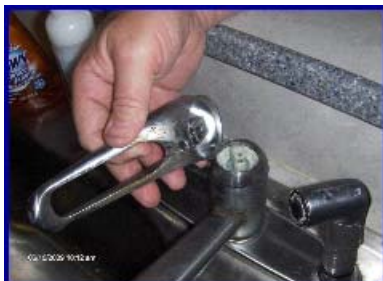
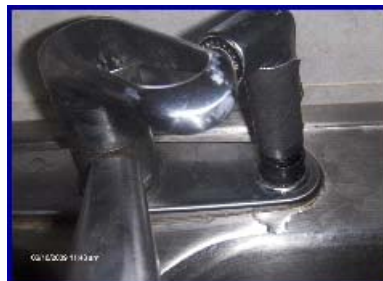
10.11 Faucet

17. The faucet handle needs to be secured.

The hand sprayer is not functioning properly and needs maintenance.

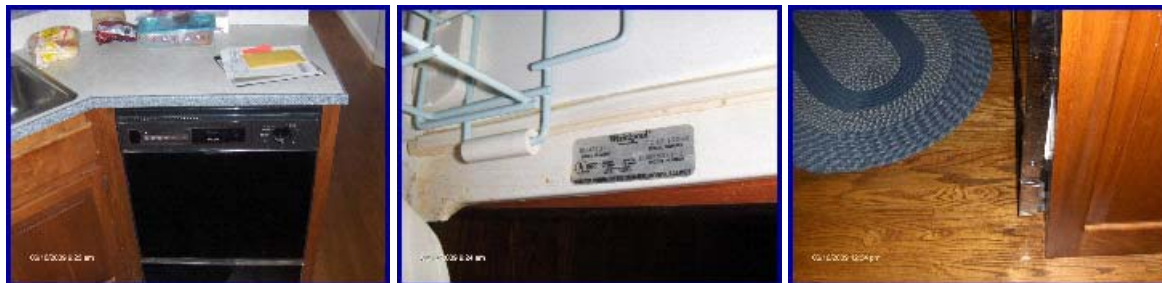
10.16 Dishwasher

Dishwasher not properly installed and needs adjusted to fit the opening correctly.

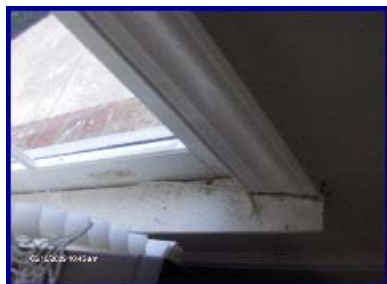
13.7 Window or Windows

19. The window or windows are double pane.
The window sill is loose and will need maintenance.
The window or windows allow egress.

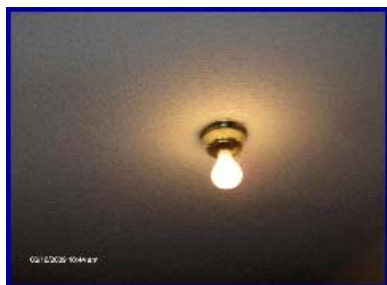
13.8 Closet or Closets

20. The globe in the closet is missing.

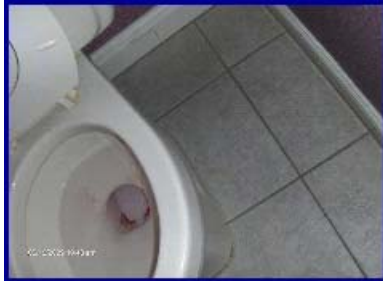
14.12 Toilet / Bidet

22. Toilet: The toilet is loose, and should be secured.

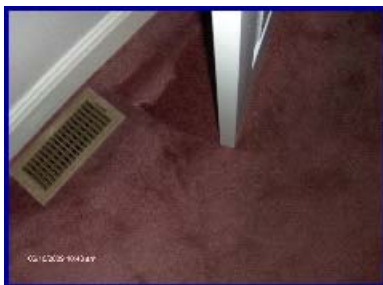
14.15 Door or Doors

23. The interior door rubs and needs to be serviced to work smoothly.

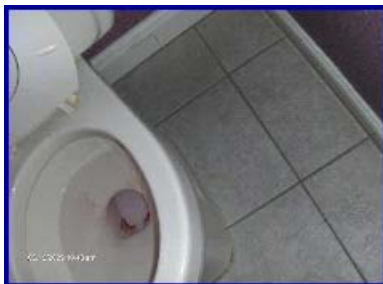
14.26 Toilet / Bidet

24. Toilet: The toilet is loose, and should be secured.

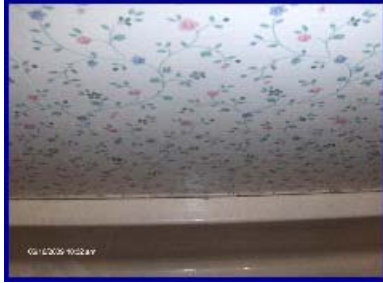
14.40 Sink Area

25. Countertop: There is a separation between the sink and the countertop, which should be sealed to forestall moisture damage.

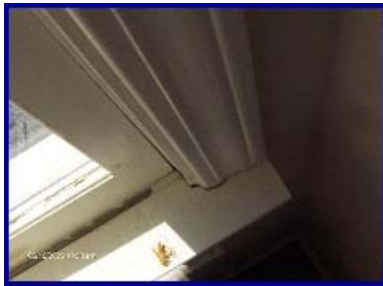
14.49 Window or Windows

26. The window or windows are double pane.

The window sill is loose and will need maintenance to work properly.

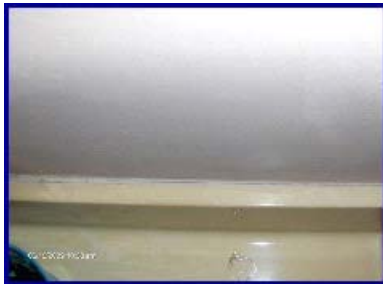
14.53 Sink Area

27. Countertop: There is separation between the sink and the countertop, which should be sealed to forestall moisture damage.

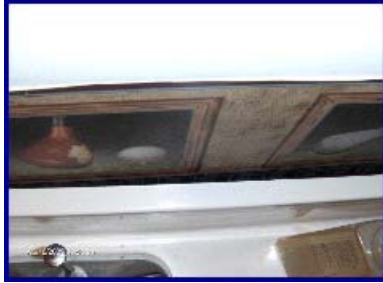
14.67 Sink Area

28. Countertop: There is a separation between the sink and the countertop, which should be sealed to forestall moisture damage.

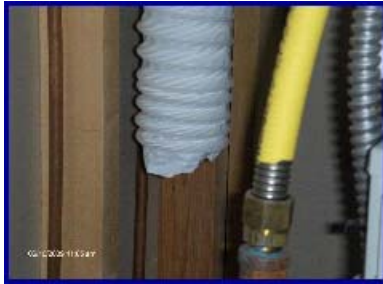
14.69 Exhaust Fan

30. The exhaust vents improperly into the garage and should be vented to the exterior.

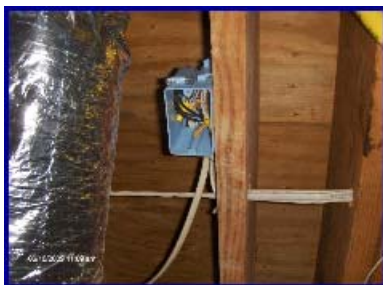
15.5 Electrical

31. There are open electrical junction boxes, which should be sealed to contain any arcing or sparking that might occur.

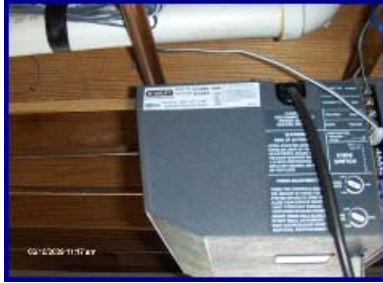
15.12 Automatic Opener

32. One of the garage automatic openers need service to work properly.

The other opener is not equipped with infra-red sensors that enable the door to auto-reverse, which is obviously a desirable safety feature.
